Replacement of Lake Irogami Weir

Site Preparation

Installation of New Weir Assembly

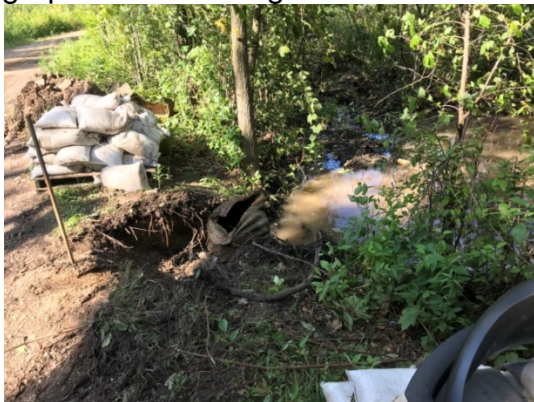
Original exit pipe bent to prevent water backup.

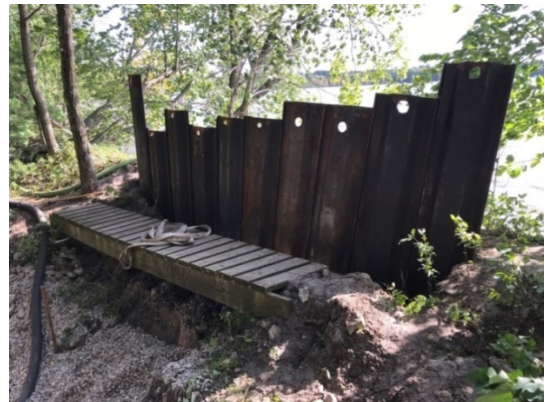
Sheet piling to isolate weir construction area.

Pile sheeting was used to reduce water flow from Lake Irogami. The remaining water infiltration was pumped from the weir pit and returned to Lake Irogami. Sand bags were used at the discharge pond entrance to Thorstad Creek to prevent water back flowing to the discharge pond. The discharge end of the existing 18-inch discharge pipe was bent up to prevent water back flowing to the weir. Erosion was controlled using standard porous screen material.

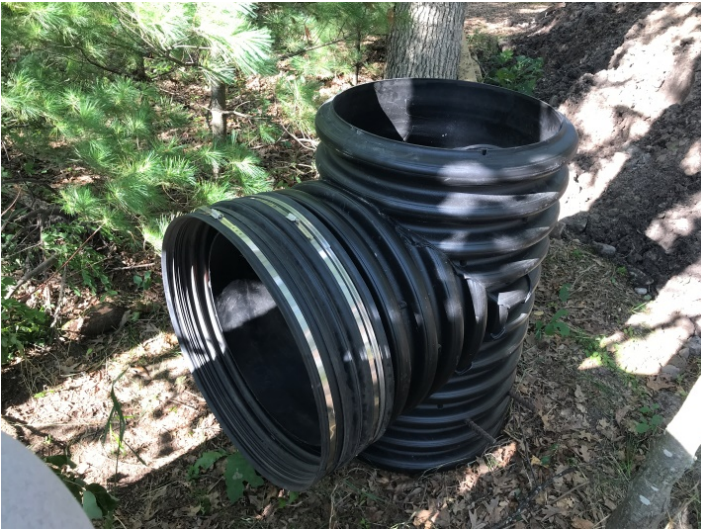
Weir tee assembly.

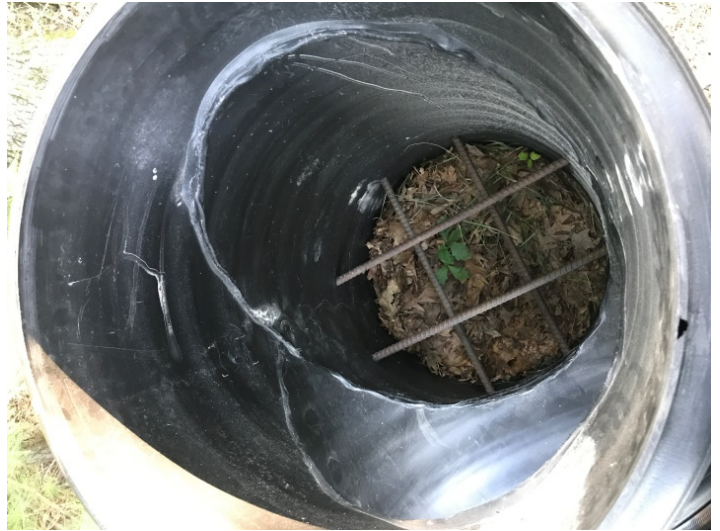
Rebar rods to stabilize structure. Concrete added in bottom of tee up to the side discharge.

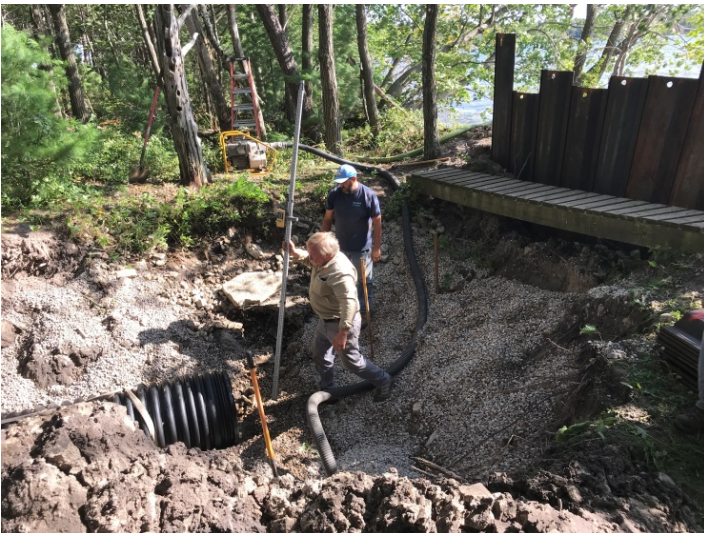
Water infiltration pumped back into Lake Irogami. Elevations continuously measured.

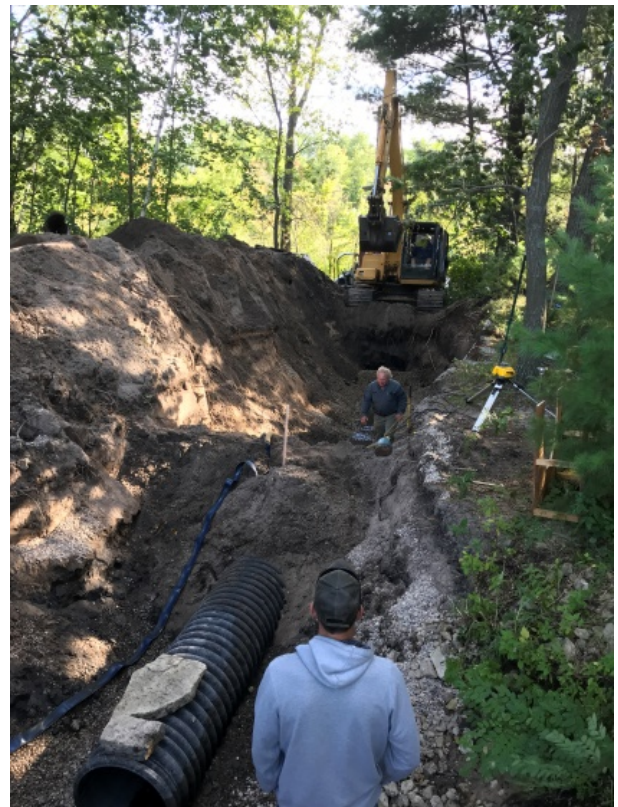
Middle pipe section installed first. Gravel placed under discharge pipe.

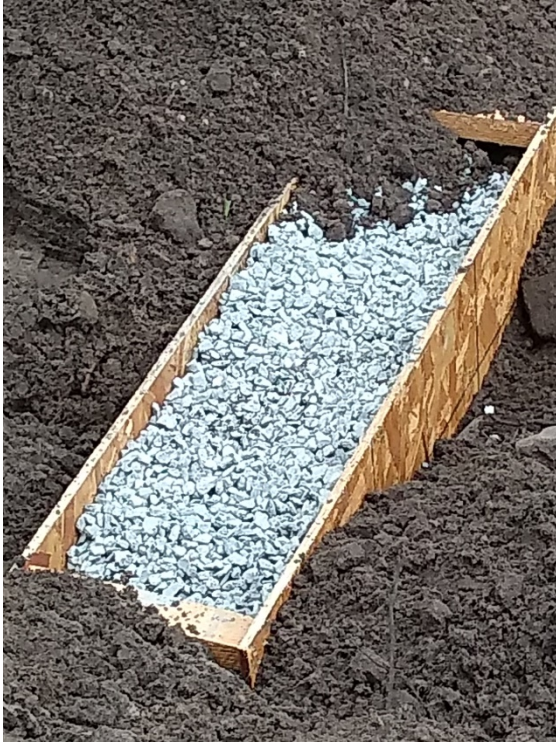
Bentonite saddles used to stabilize discharge pipe.

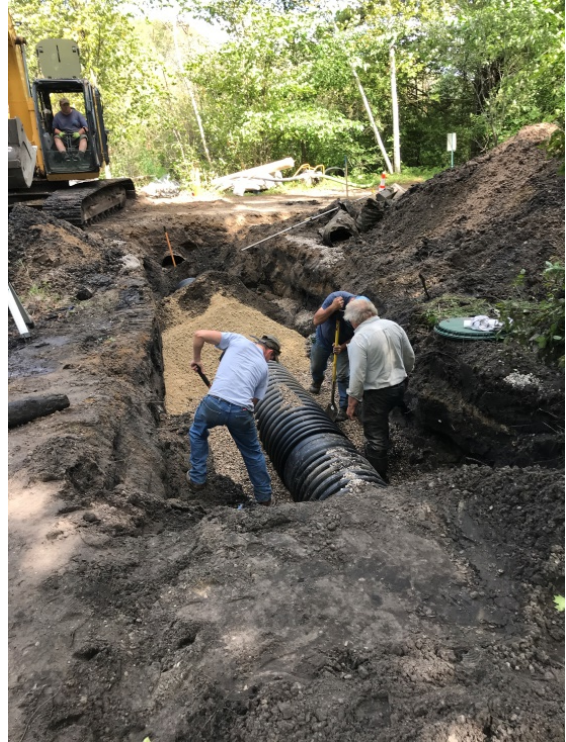
Discharge pipe elevation set and stabilized with gravel.

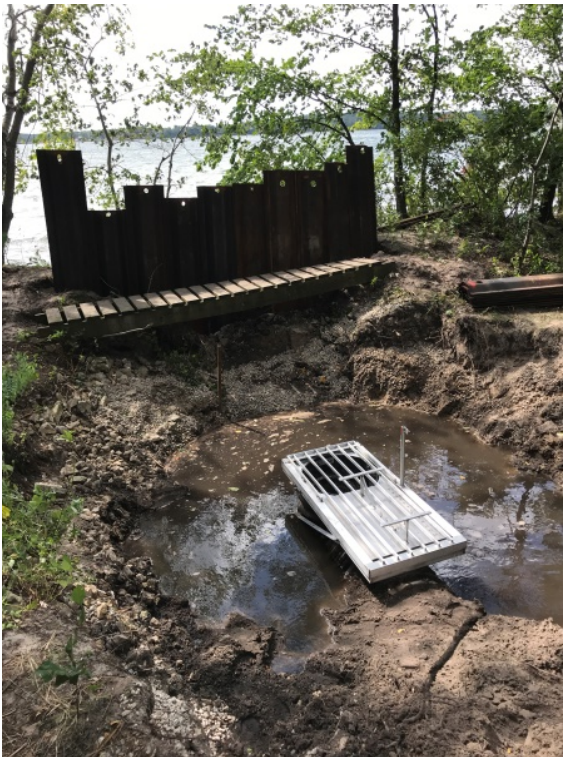
Slide gate assembly bolted to weir tee.
Top of riser pipe set at 867.60'

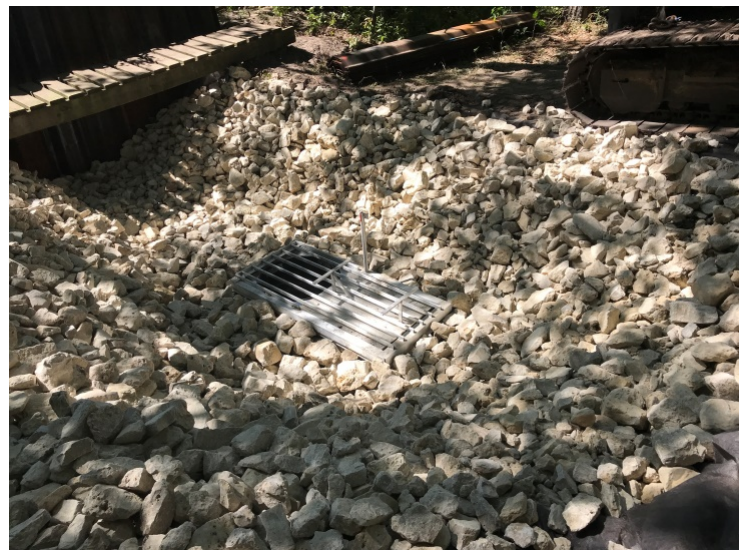
Weir inlet channel lined with riprap over porous fabric liner.

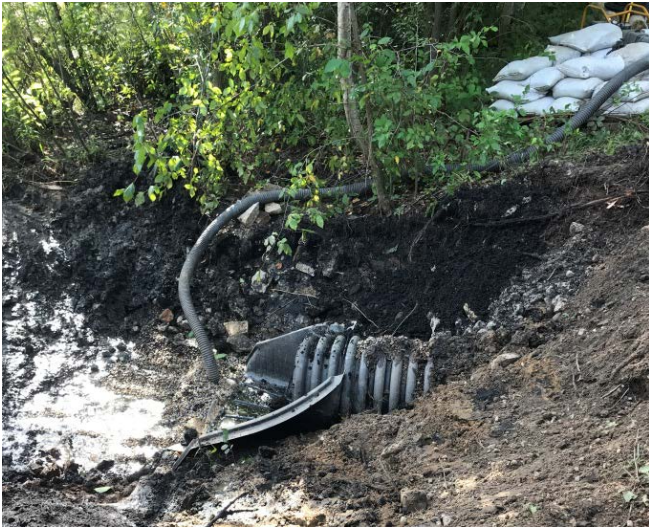
Exit pipe spillway.
Infiltrated water pumped to marsh.

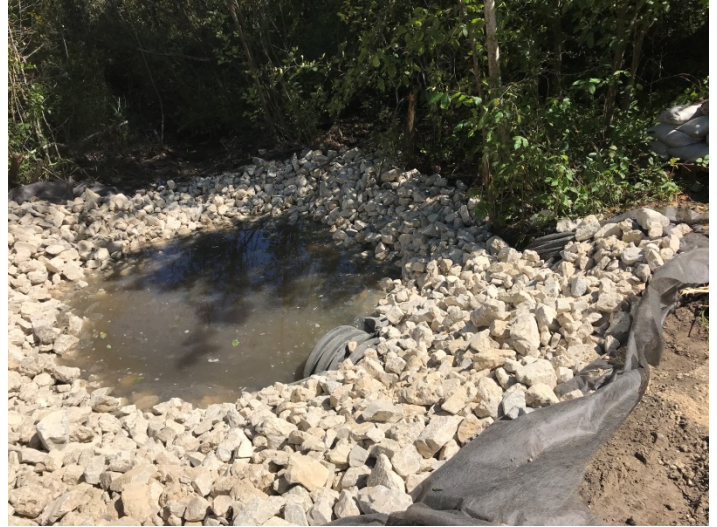
Outlet with riprap and silt barrier installed.
(weir not flowing)

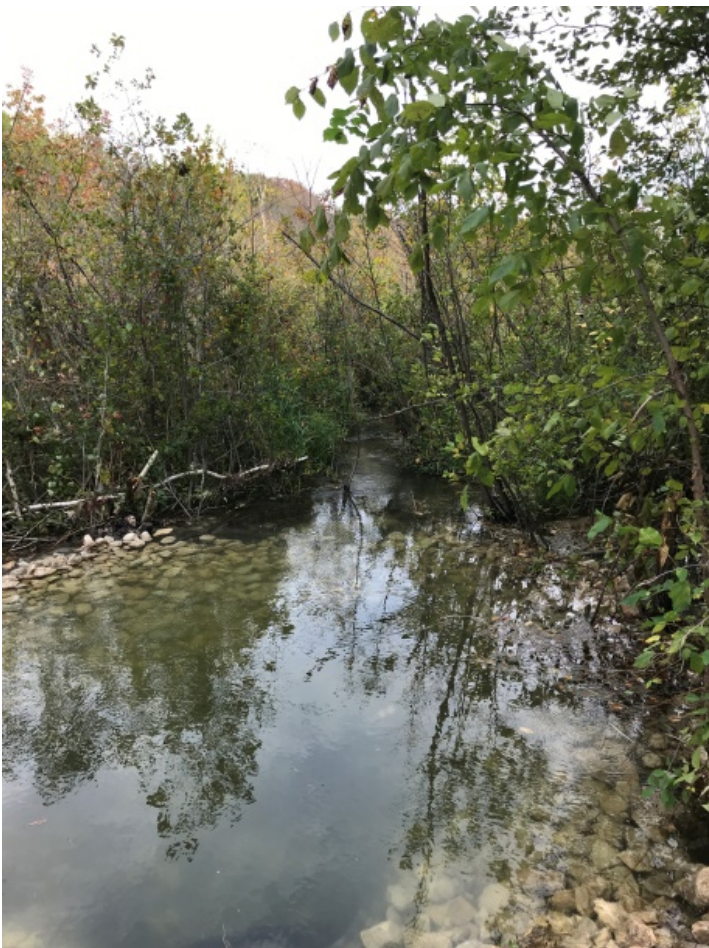
Discharge pipe outlet under flow conditions.

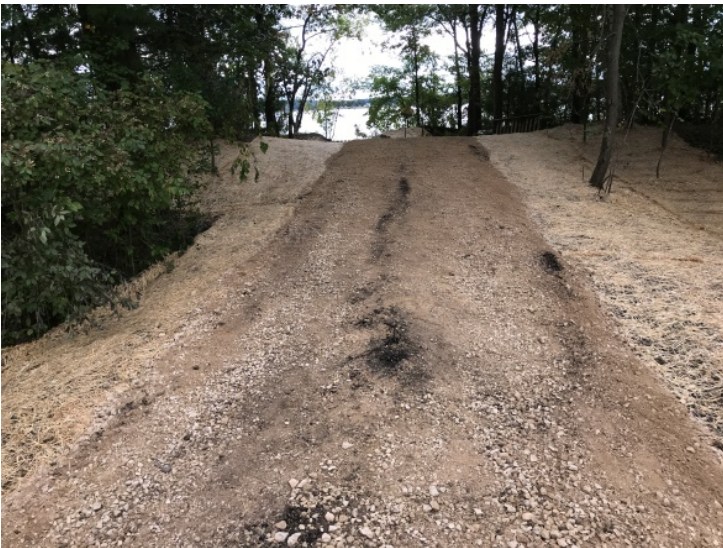
Rebuilt driveway.
Facing south.

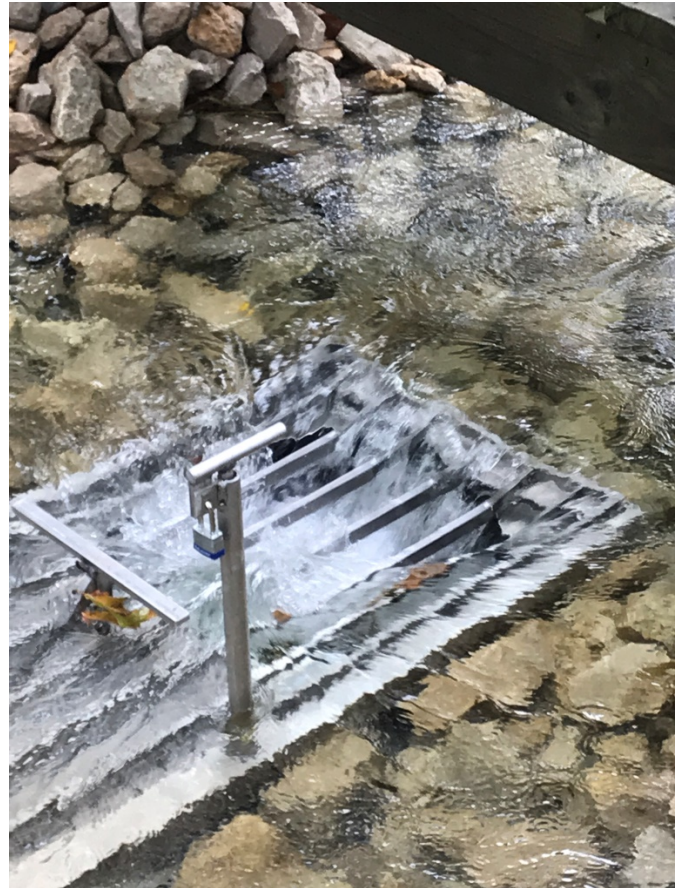
Slide gate lock and level indicator

The slide gate worked well as one person can easily open/close the gate manually. When the gate is closed there is essentially no flow and the inlet flow elevation becomes the same as the level of Lake Irogami.

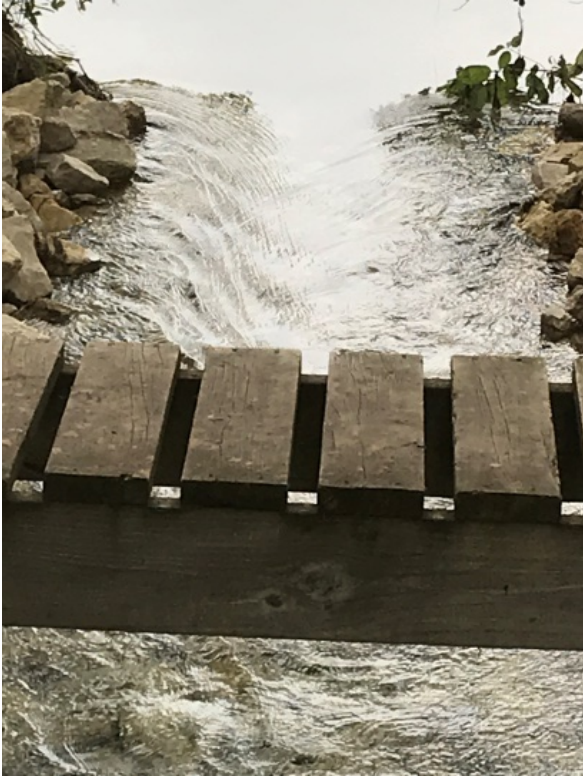
Inlet channel from Lake Irogami.
Weir flowing at ~5cfs

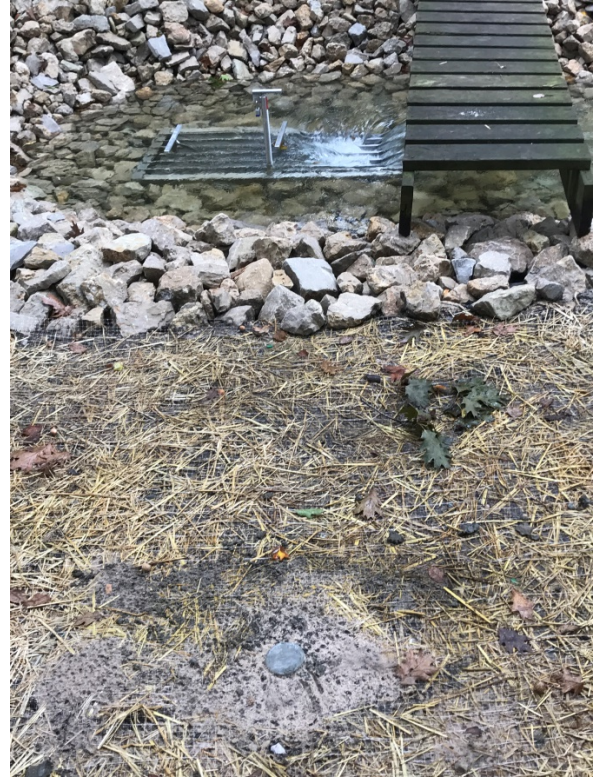
Surveyor benchmark at 869.61' located
13' NW of center of weir opening

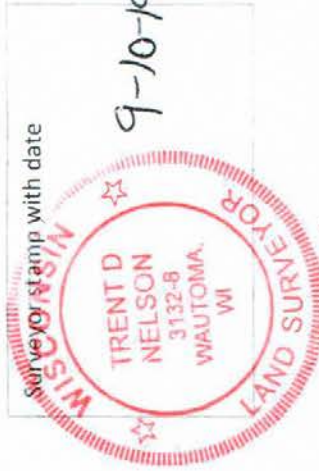
WEIR ON LAKE IROGAMI (AS-BUILT)

High point on driveway elevation 872.37 feet

top of riser pipe elevation = 867.60 feet

riser pipe diameter = 2 feet (24 inches)

distance between riser and land = 5 1/2 feet

20th Lane centerline elevation = 868.68 feet

top of pipe elevation = 866.32 feet

outlet pipe diameter and material = 2 feet (24 inches) HDPE

invert elevation = 864.95 feet

outlet invert elevation = 864.28 feet

outlet pipe length = 131 feet

The installation followed the as-proposed plan submitted previously with the exception of a lowering of the outlet invert elevation about 0.8 feet to accommodate the increased diameter of the weir discharge pipe. This change also eliminated the need to raise the road elevation (hump) to provide sufficient cover of the discharge pipe and gave an improved drainage pitch for the discharge pipe.

A diagram showing elevations of the as-built weir system is attached.

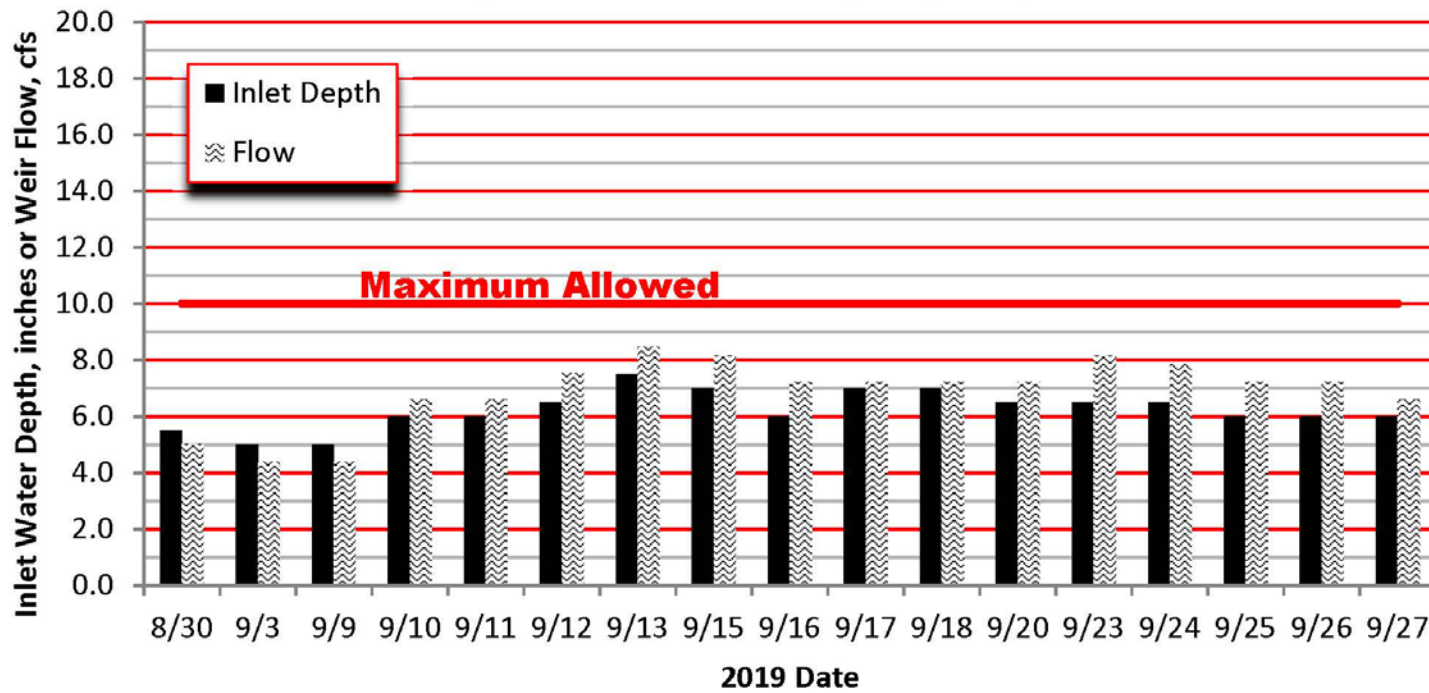
Lake Irogami Inlet Water Depth and Weir Flow (Slide Gate Fully Open)

The suspended ball time-travel method of measuring average linear velocity was not successful at an inlet flow head of 5.5" due to turbulence occurring in the riser pipe. The ball at times actually flowed back to the riser in the turbulent flow. Results using a Global Flow Probe agreed with results using a dye time-travel method. The flow calculated at this inlet head was about 5cfs, which is in the range of what the Stantec theoretical flow calculations predict for this inlet head. At a flow of 5cfs, there is an inlet head loss in the channel from Lake Irogami of about 2.0". The dense foliage in the swamp provides some resistance to flow (back pressure) from the discharge pipe. This resistance amounts to a back pressure head of about 3.5" at 5.0cfs, but does not significantly affect flow through the 24" discharge pipe.

Because of recent weather conditions, Lake Irogami has decreased in level and is now about 8" above the Ordinary High Water Mark (OHWM). During the first month of operation, readings will be taken and recorded at least twice per week or more frequently if a substantial (e.g. >2") rain event occurs. Thereafter, readings will be taken and recorded at least once per week. If the lake level increases, thus increasing the flow through the weir, the slide gate position will be adjusted to limit the flow to a maximum of 10cfs. The data recorded will be stored at the SLSD office. It is intended to develop operating curves regarding the relationship of weir throughput as a function of inlet water depths and slide gate setting. A summary of the data obtained similar to the chart attached will be shared at least bi-weekly with the property owner and Irogami Lake Management.
